REFURBISHED ANCILLARY EQUIPMENT.

Multiflow 150S Pump Module powered by C9 Caterpillar failed fan Assembly.

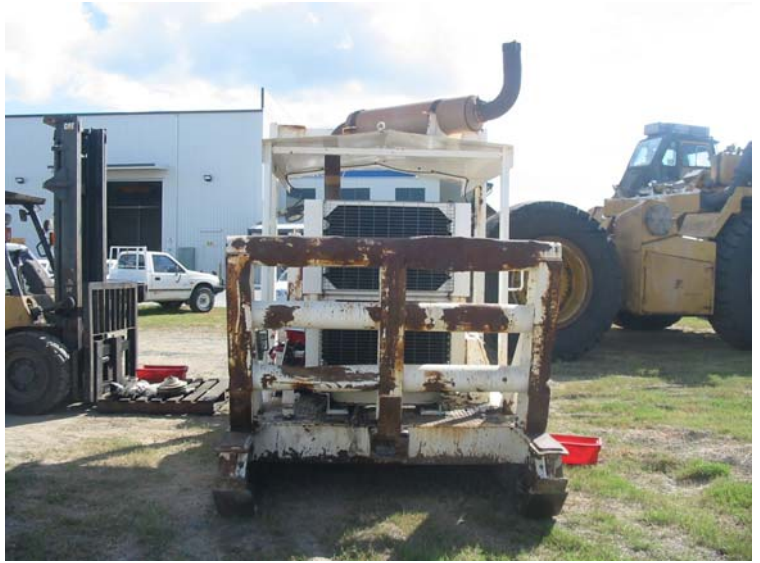
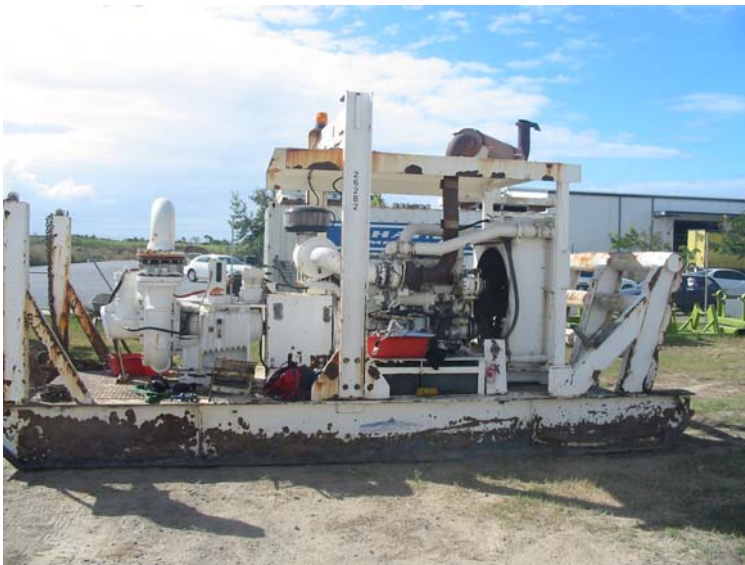
Before Repair

Unit was completely dismantled, fuel tank required repairs due to leaks and structural damage, Pump unit was only recently replaced and only required servicing, drive was rebuilt, Engine repairs were carried out and cooling system was overhauled as per client's direction. Structure was cleaned up and damage repaired as authorised, Unit was blasted, primed and final paint coated in two pack paint, Unit was performance tested, all shut downs were verified and repaired as needed before returning to site.

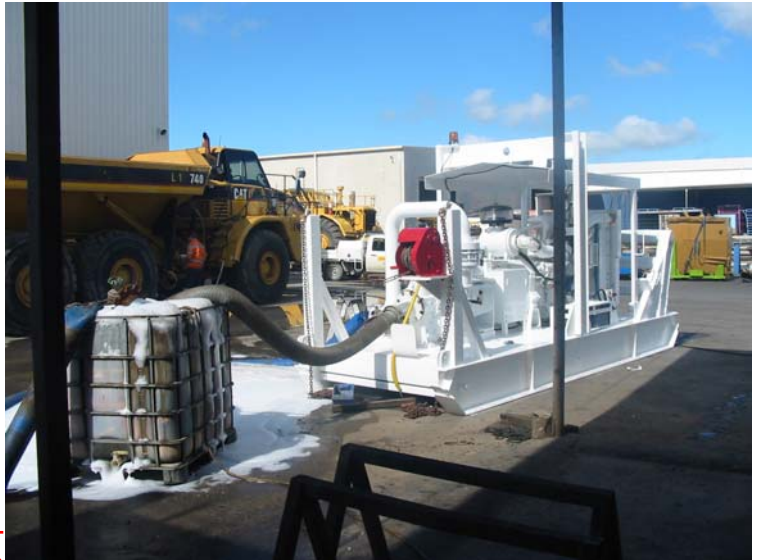
Testing

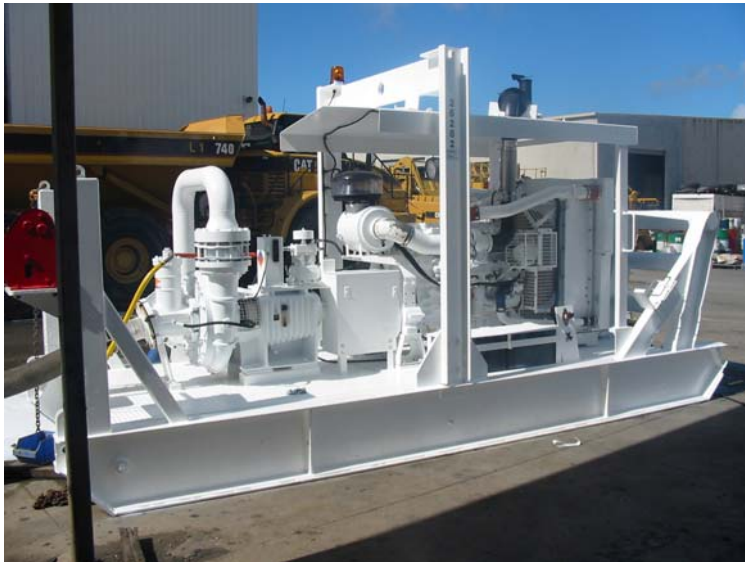
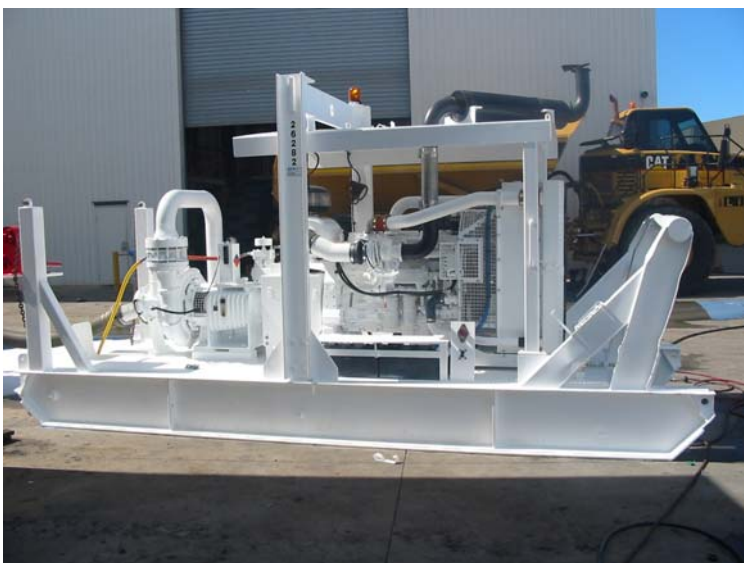
Ready to Ship

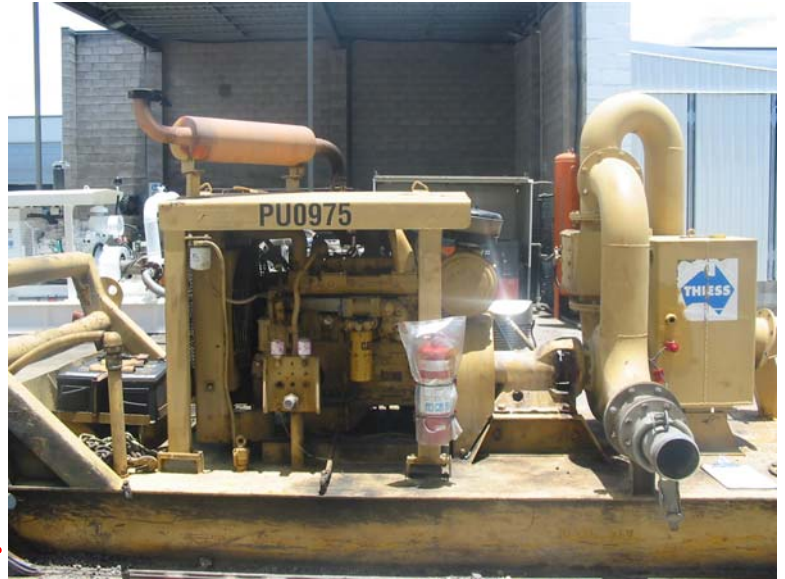
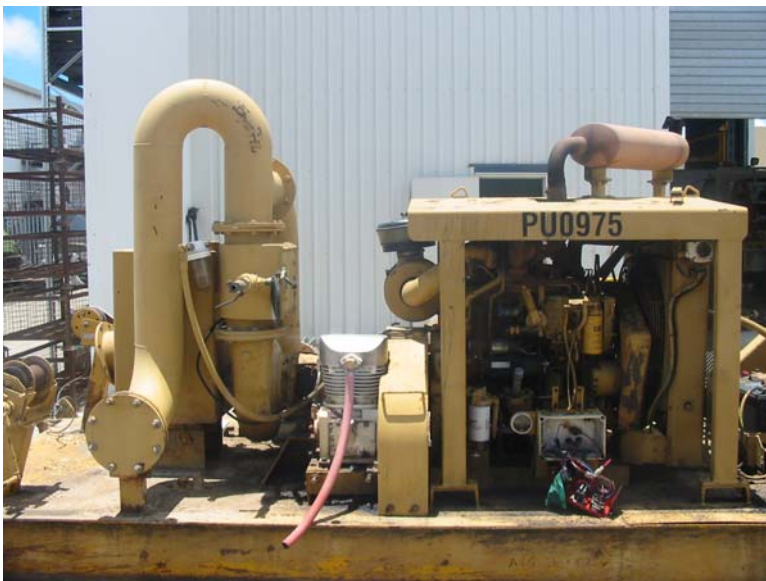
Unit 2

Before Repair

Multiflow 200S Pump Module

This unit required a full rebuild and Engine upgrade due to age and condition, Unit was originally powered by 3204 Caterpillar and was Modernised using a Cummins 6B-5.9C power pack as requested by client. All electrics were upgraded to latest mine Specs and repaired as required, Wet end was rebuilt using all new components, Drive coupling was upgraded and aligned, Skid base was completely service including modifications to accept new Engine configuration. Unit was totally re-hosed and performance tested on completion of repairs, please see after Photo's on next page.

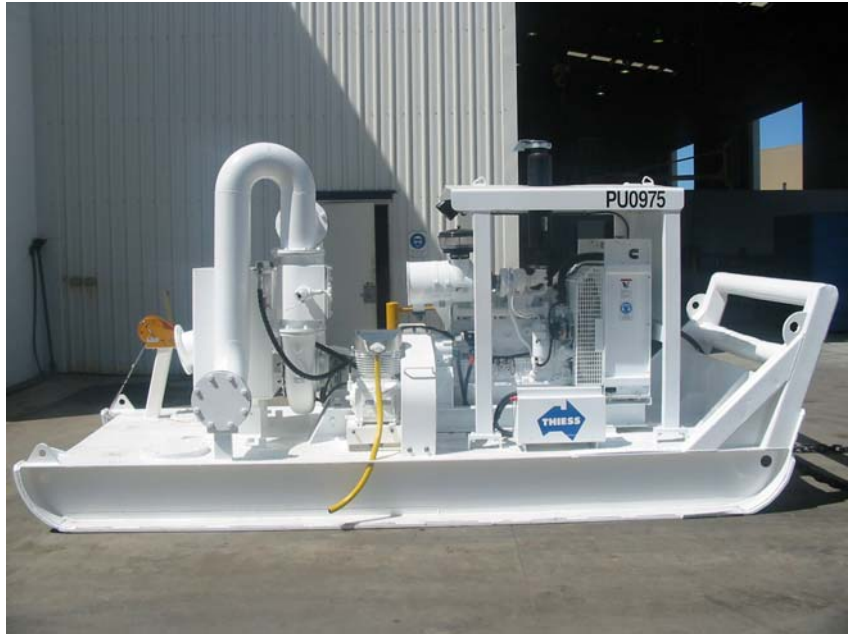
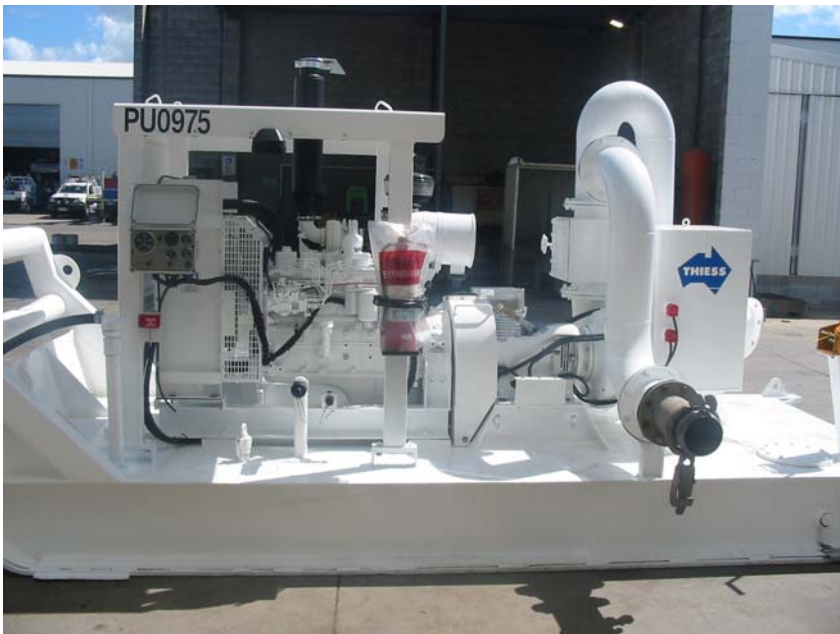
**After Rebuild
Multiflow 200S Pump Module.**
